**DEPARTMENT OF TRANSPORTATION**

Contract #: 04-0120F4Cty: SF/ALA Rte: 80 PM: 13.2/13.9File #: 69.28**WELDING INSPECTION REPORT****Resident Engineer:**Pursell, Gary**Address:** 333 Burma Road**City:** Oakland, CA 94607**Report No:** WIR-012754**Date Inspected:** 13-Mar-2010**Project Name:** SAS Superstructure**OSM Arrival Time:** 700**Prime Contractor:** American Bridge/Fluor Enterprises, a JV**OSM Departure Time:** 1900**Contractor:** Zhenhua Port Machinery Company, Ltd (ZPMC), Changxing Island **Location:** Shanghai, China

Orthotropic Box Girder (OBG) Trial Assembly Areas

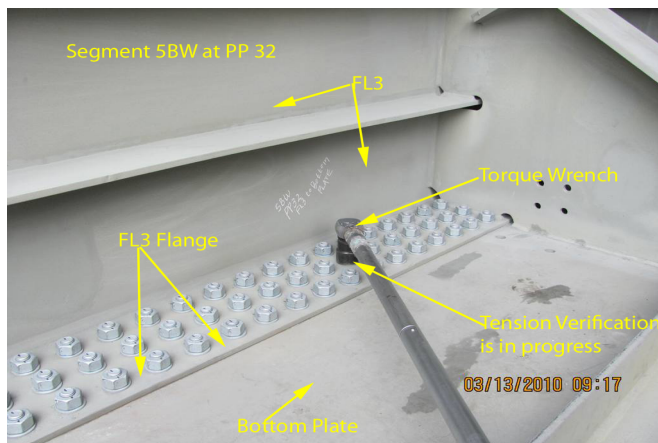
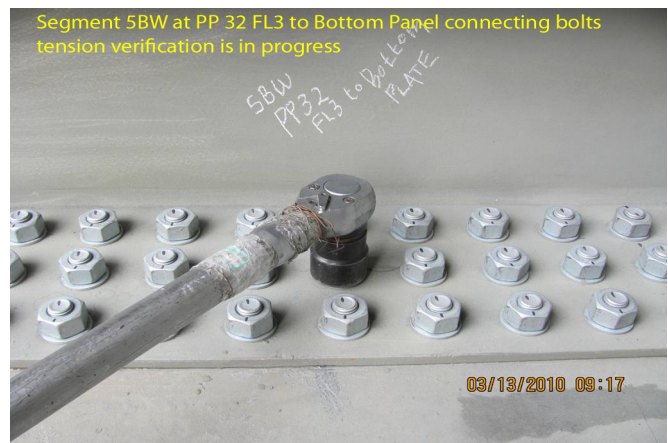
This Quality Assurance (QA) Inspector witnessed final tension verification for Bolts connecting FL3 flange to the Bottom Plate at Panel Point (PP) 32, PP 33 and PP 34 for Segment 5BW. Inspected bolts tension on a random basis and found the tension to be in general compliance. Inspection was performed against the Notification No. 00278 Dated March 13, 2010.

Note: Few bolts at PP 32, PP 33 and PP 34 bolts not installed due to the temporary bolts been installed. Please refer the pictures attached below for more comprehensive details.
